Manhole Inspection Summary

Manhole # S39A2_009MH

Insp Date: **4/9/08 9:43 AM**

Location Address: **E. Talbott St. (Near the Church)**

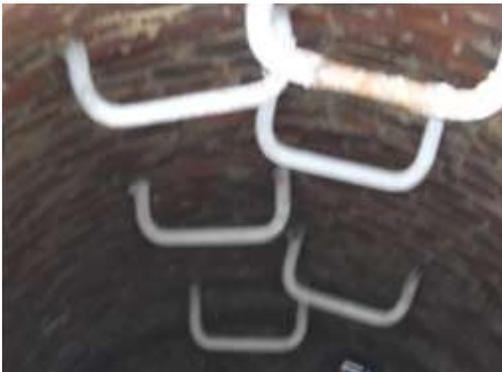
Steps

Count: **6** Missing: **0** **Corroded**

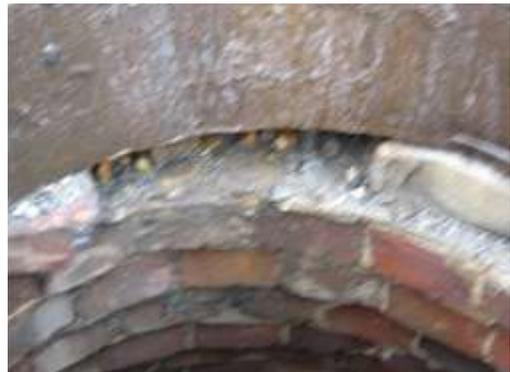
Defect 1

Condition: Sound **Cracked** Root Intrusion **Loose Brick** Deteriorated

Infiltration: None **Joint** Cracks Mortar Roots Wall

Missing bricks/cracks

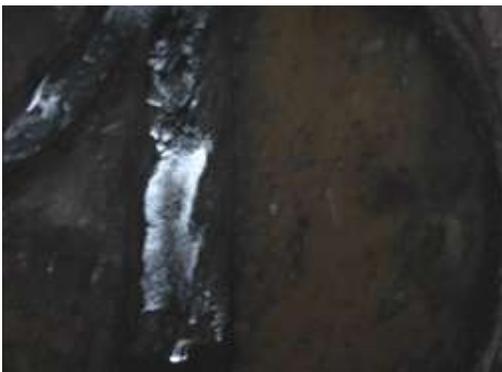
Defect 2

Condition: Sound Cracked Root Intrusion Deteriorated Leaks **Debris**

Debris on bench

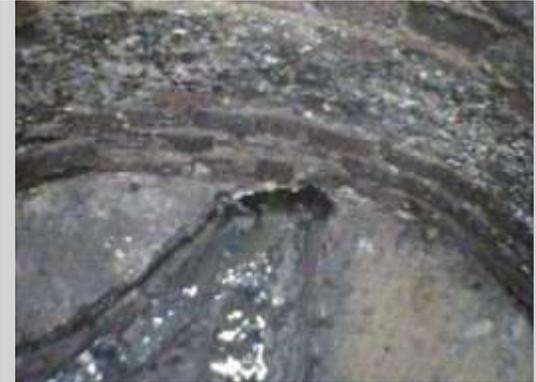
12 O'Clock Outflow

Pipe Height: **9.6** (in.) Rod and Bar (Angled)
Pipe Material: **Clay** Pipe Lined
Invert Depth: **12.70** (ft.) Flow Characteristics: **Fast**
Deposits: None Mud Sludge Debris Grease
Silt Depth: (in.) Deposits Extent:
Infiltration: **None** Pipe Seal Cond: **Unknown**

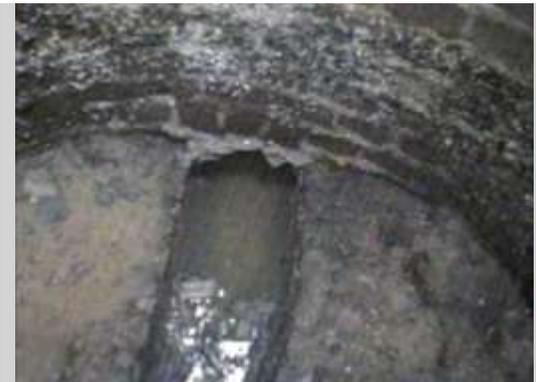
6 O'Clock Inflow

Pipe Height: **9.6** (in.) Rod and Bar (Angled)
Pipe Material: **Clay** Pipe Lined
Invert Depth: **12.52** (ft.) Flow Characteristics: **Fast**
Deposits: None Mud Sludge Debris Grease
Silt Depth: (in.) Deposits Extent:
Infiltration: **None** Pipe Seal Cond: **Unknown**

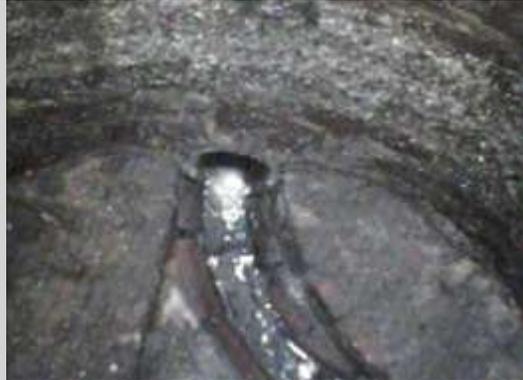
9 O'Clock Inflow

Pipe Height: **8.4** (in.) Rod and Bar (Angled)

Pipe Material: **Clay** Pipe Lined

Invert Depth: **12.18** (ft.) Flow Characteristics: **Fast**

Infiltration: **None** Pipe Seal Cond: **Unknown**
